Report No : GIS-13041592.

INSPECTION REPORT

Attn	:	-	
Supplier	:	-	
Factory	:	-	
Factory Address	:	-	
P/O No.	:	BTT-425/2012	
P/O Quantity	:	1572	
Model/Art/Style	:	MD-213B	
Product Description	:	Coffee Maker	
Inspection type	:	Pre-shipment Inspection	
Inspection method	:	<input checked="" type="checkbox"/> GWI-IE	
Inspection date	:	20XX-XX-XX

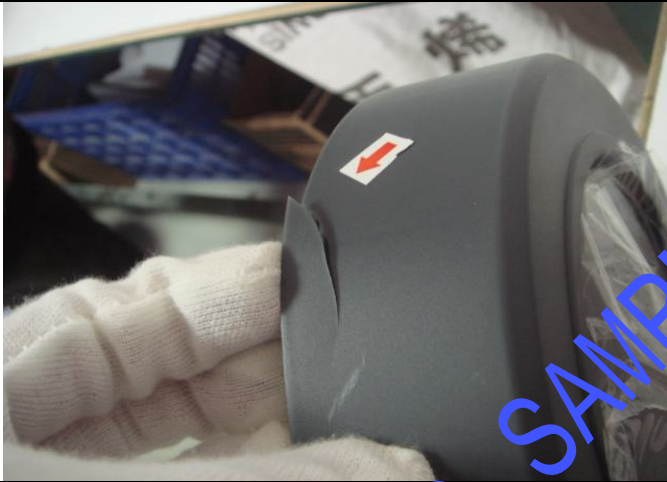
Inspection Standard: ANSI/ASQC Z1.4		Defect classification	Cr	Ma	Mi
Sampling Plan:	Single, Normal	AQL	0	1.0	2.5
Inspection Level:	<input checked="" type="checkbox"/> G-II	Sample size	125	125	125
The defects which were found during inspection were listed as below:					
Item: MD-213B					
1	Broken mark on housing		-	1	-
2	Water tank leakage (hi-pot is ok)		-	1	-
3	Foreign plastic part was inside of unit		-	1	-
4	Dirty mark inside of Thermos carafe		-		1
5	Scratch mark on unit		-	-	3
Total Found:			0	3	4
Allowed:			0	3	7
Result			Pass

69_defect-broken mark on housing

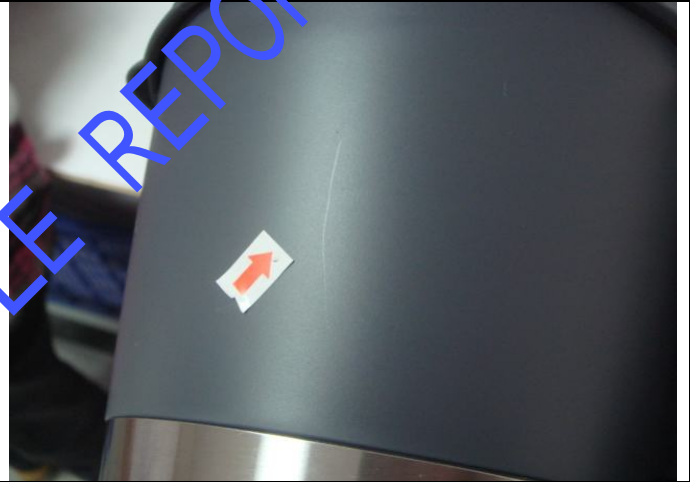
70_defect-scratch mark on unit

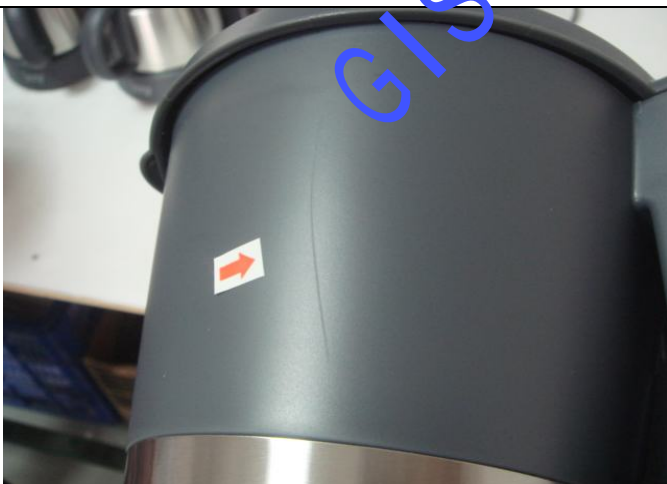
71-scratch mark on unit

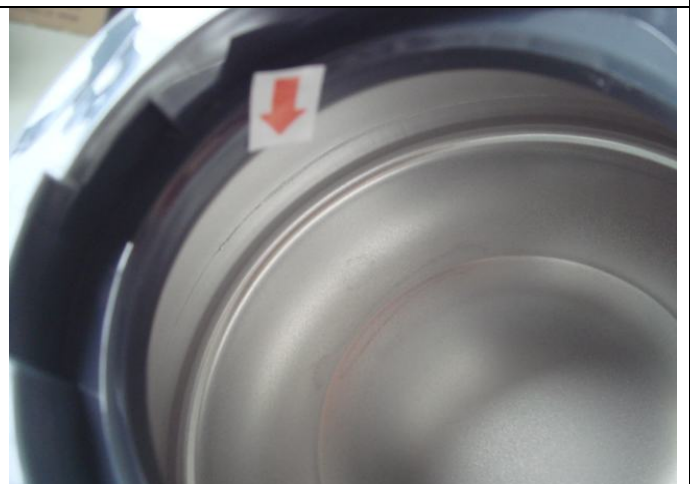
72_defect-dirty mark inside of thermal carafe

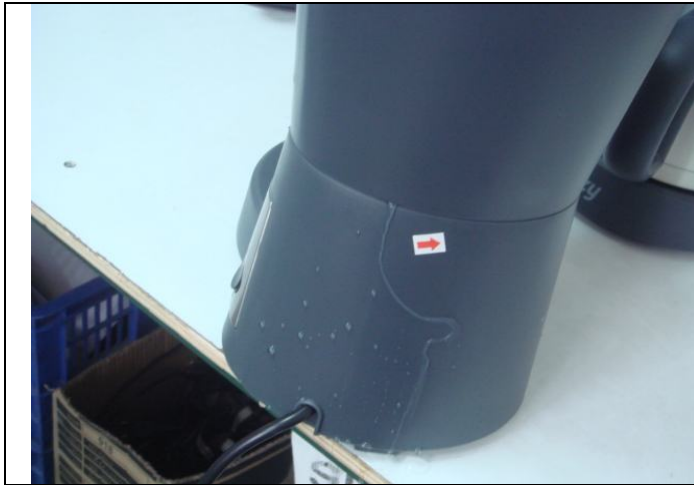
73_defect-water tank leakage

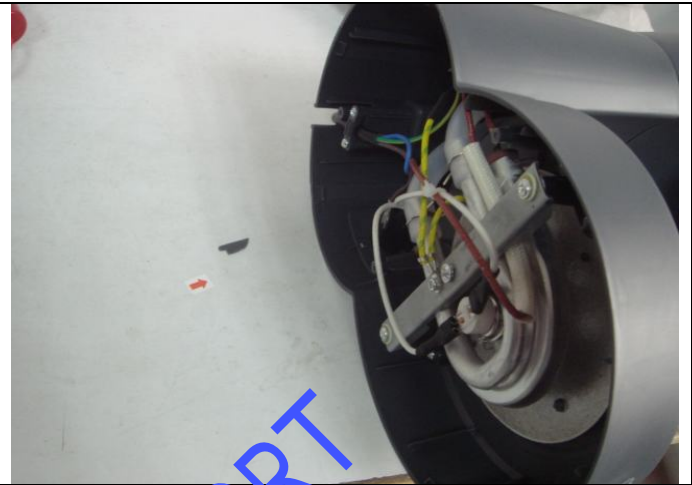
74_defect foreign plastic part was inside of unit
