Report No : GIS-21040599

INSPECTION REPORT

Applicant	:	-	
Attn	:	-	
Supplier	:	-	
Factory	:	-	
Factory Address	:	Shanghai, China	
P/O No.	:	--	
P/O Quantity	:	2 sets	
Model/Art/Style	:	Hitachi EX120, Komatsu PC120	
Product Description	:	Used excavators	
Inspection type	:	Pre-shipment Inspection	
Inspection method	:	<input checked="" type="checkbox"/> GWI-IC	
Inspection date	:	20XX-XX-XX

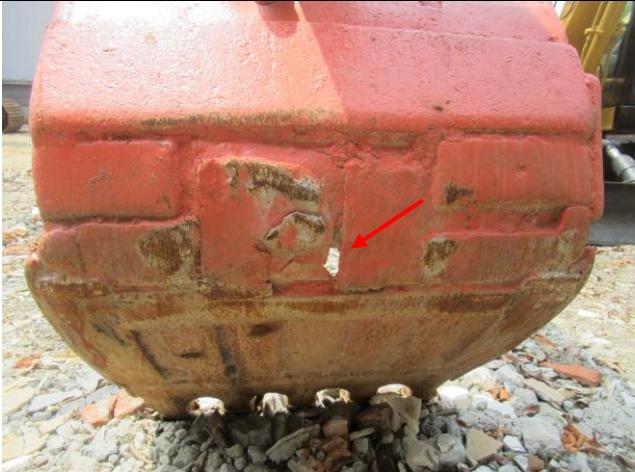
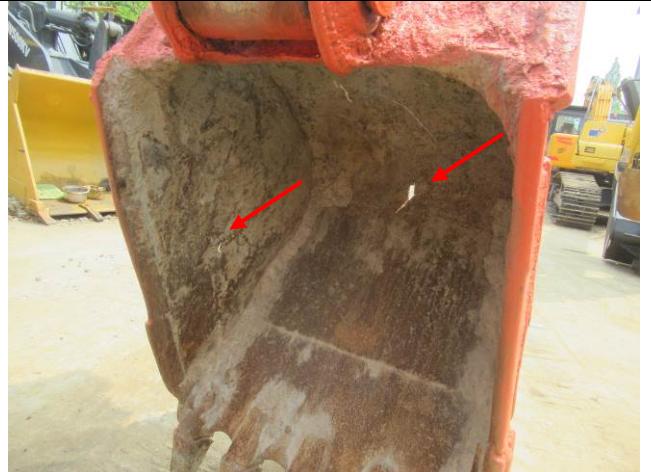
1	The suppliers could not provide any documents.
2	For Hitachi EX120, some problems were found as below: 1. No rating plate was found on the excavator. 2. Actual found crack mark on bucket.

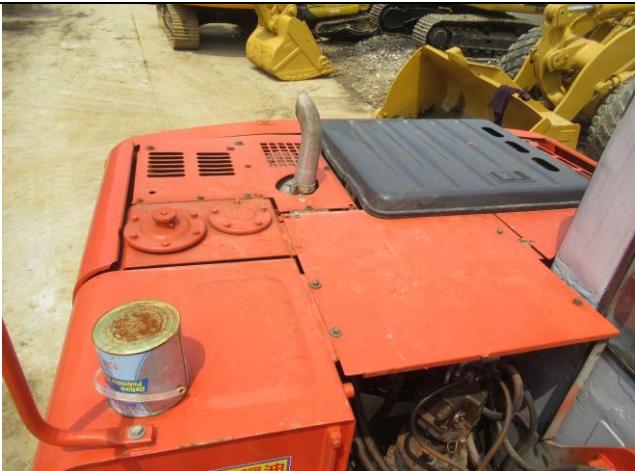
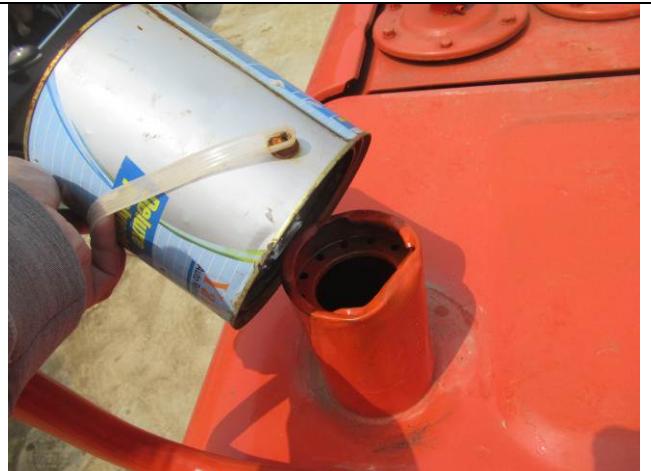
3.	No Fuel tank lid found.

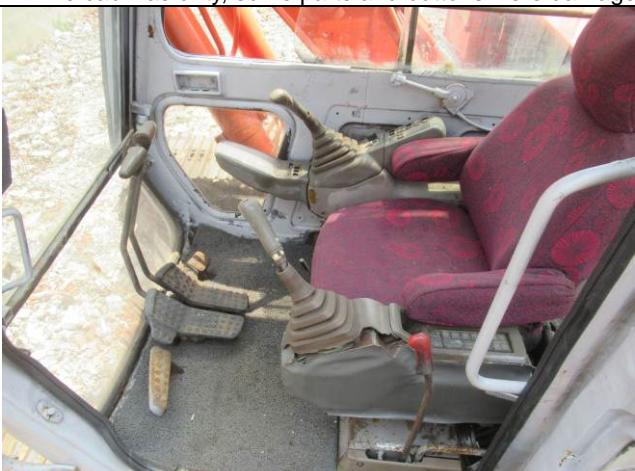
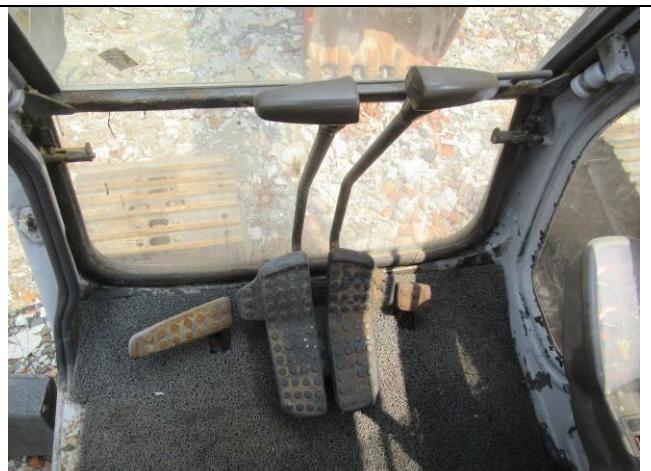
4.	The cab was dirty, some parts and buttons were damaged.
