Report No : GIS-15060333

INSPECTION REPORT

Table with 2 columns: Field Name and Value. Fields include Applicant, Attn, Supplier, Factory, Factory Address, P/O No., P/O Quantity, Model/Art/Style, Product Description, Inspection type, Inspection method, and Inspection date. Includes an image of a yellow excavator.

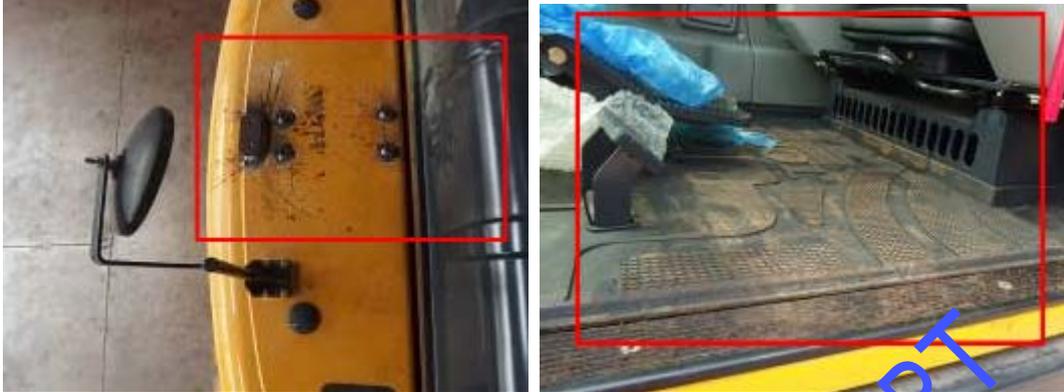
1	Until the inspection finished, the fuel pump, logo, head light, rear camera and alarm light had not been installed yet.
2	The support of rear camera was not finished and dirty mark was found on product. Details refer to photos below.

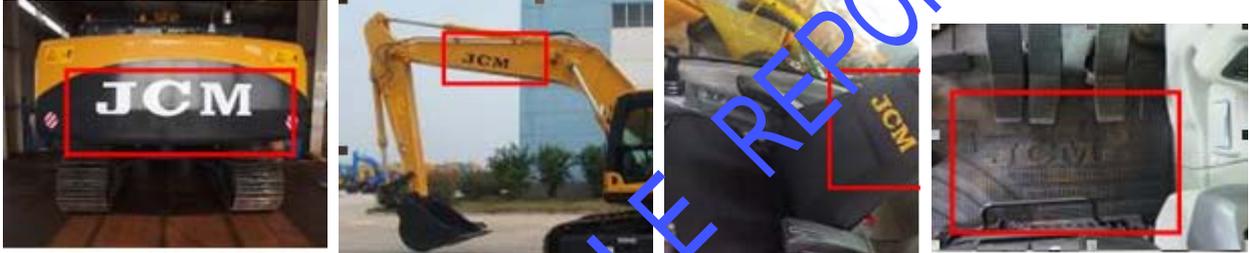
3	Actual found that the "JCM" logo on excavator was not removed. See photos as below.

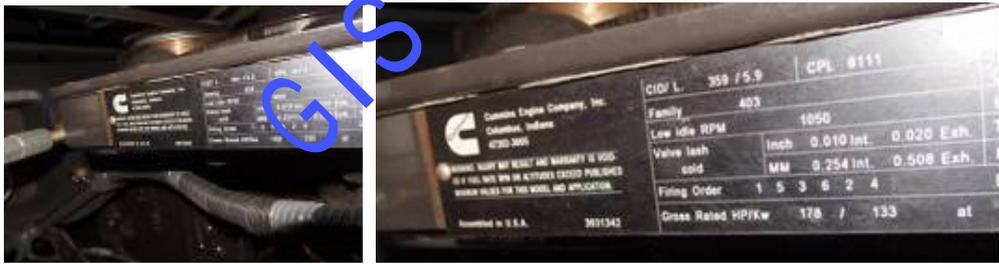
1	The nameplate of the engine was made by metal, see photos as below

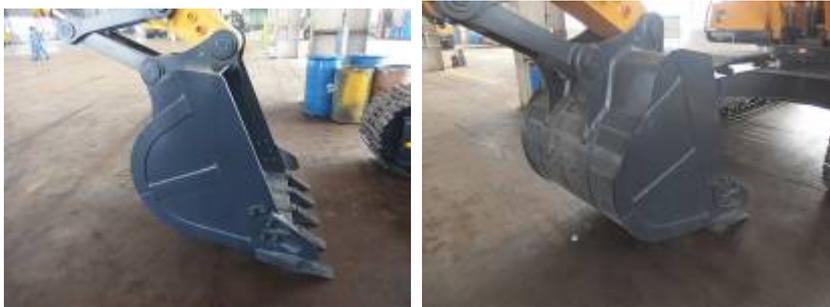
2	Actual found the bucket was common bucket instead of strength GP bucket.

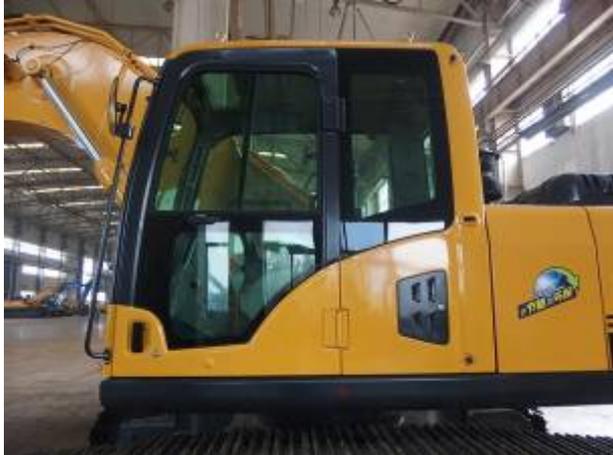
3 The glass was stuck with color film instead of tinted glass.

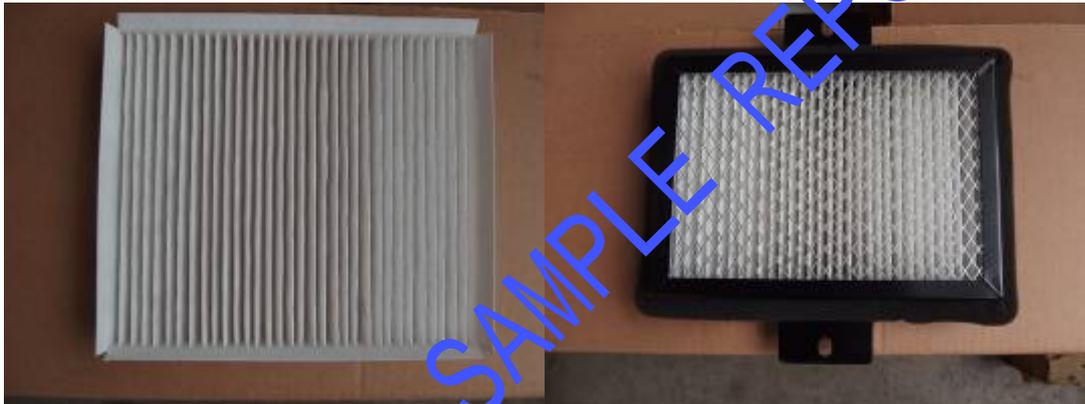
4 There was no silicone tube and clip in spare parts box. But extra 2 air conditioning meshes were in the box. 2 air conditioning meshes:
