Report No.: GIS-2606036901

## Inspection report

| Product Description: | LED Robe Kugel gross 50cm, warmweiss<br>LED Robe Kugel klein 30cm, warmweiss<br>LED Tannenbaum gold 120cm IP55<br>LED Stern gold 60cm IP55<br>LED Laterne 120cm IP55<br>LED Rentier 130cm IP55<br>LED Schneemann gold 120cm IP55<br>Set of 3 lighted glitter candle IP55<br>LED Rentier mit Schlitten (Geschenkboxen) | | | | |

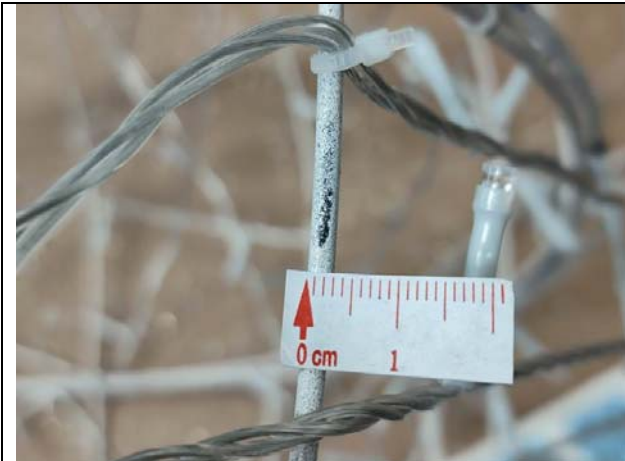
1. Minor defect- Painting peel off of item: 6.736.026

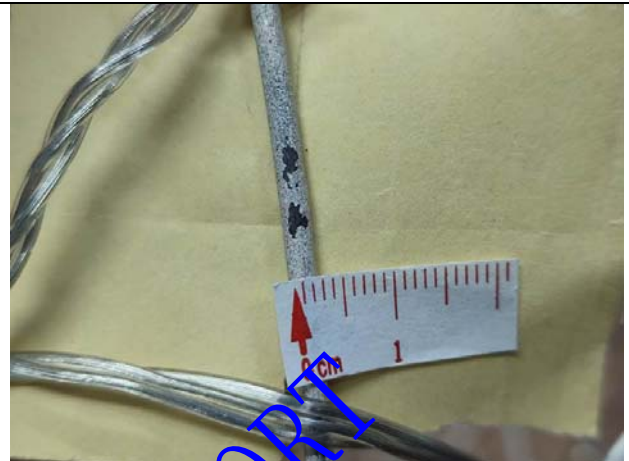
2. Minor defect- Painting peel off of item: 6.736.027

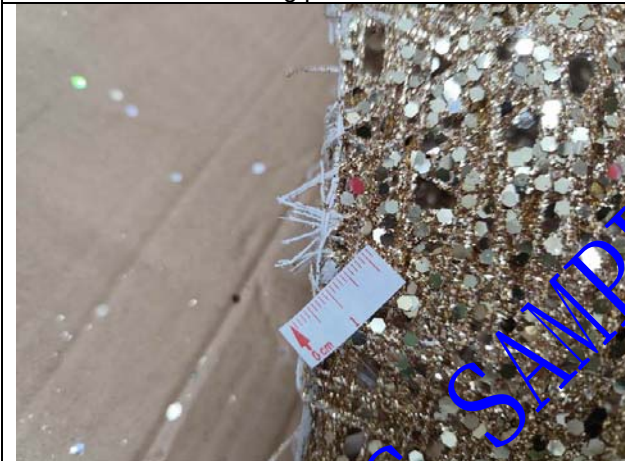
3. Minor defect- Untrimmed thread end of item: 6.968.249

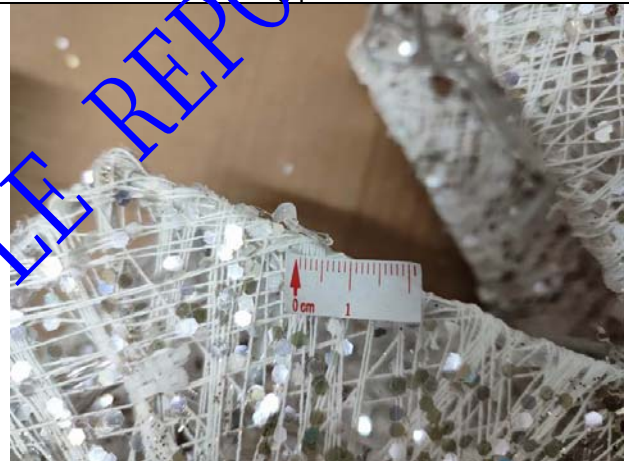
4. Minor defect- Glue mark on unit of item: 6.968.250

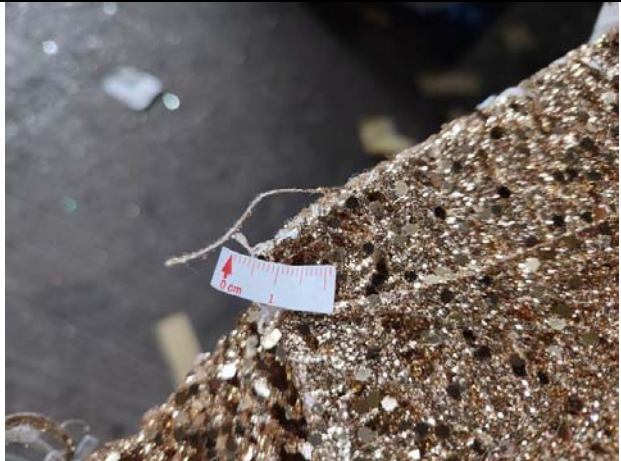
| 5. Minor defect- Untrimmed thread end of item: 6.968.250 | 6. Minor defect- Untrimmed thread end of item: 6.968.475 |

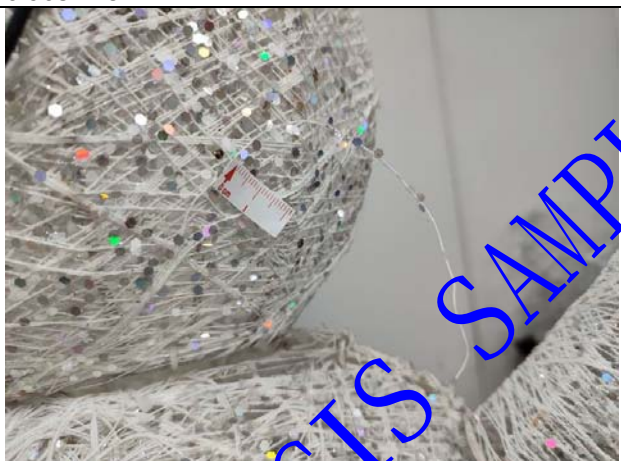
| 7. Minor defect- Untrimmed thread end of item: 6.968.475 | 8. Minor defect- Impurity on unit of item: 6.968.476 |

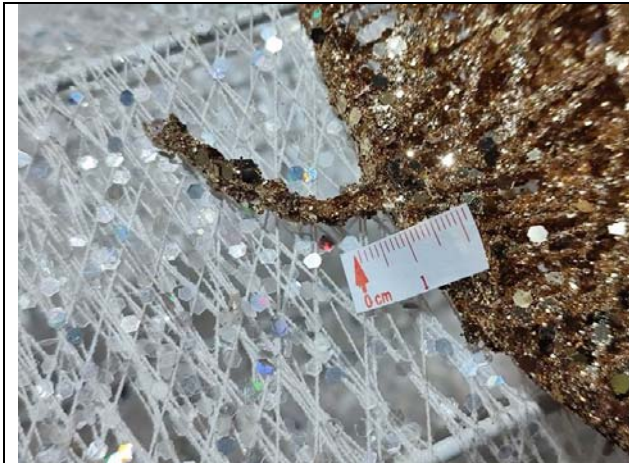
11. Minor defect- Untrimmed thread end of item:  
6.976.357

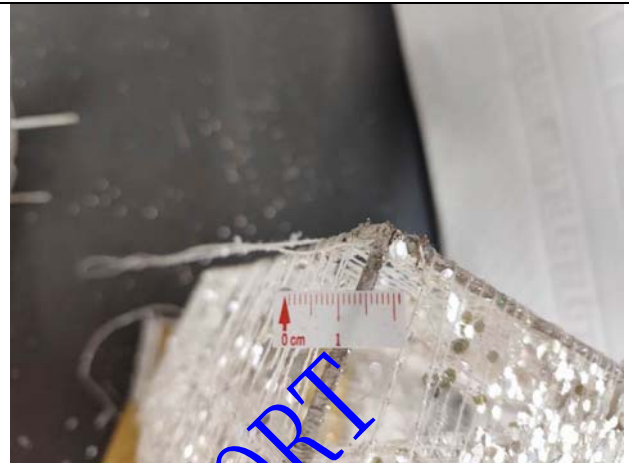
12. Minor defect- Untrimmed thread end of item:  
7.260.143
