Report No : GIS-15080091

## INSPECTION REPORT

| Product Description | : | Umbrella | |
| Inspection type | : | Pre-shipment Inspection | |

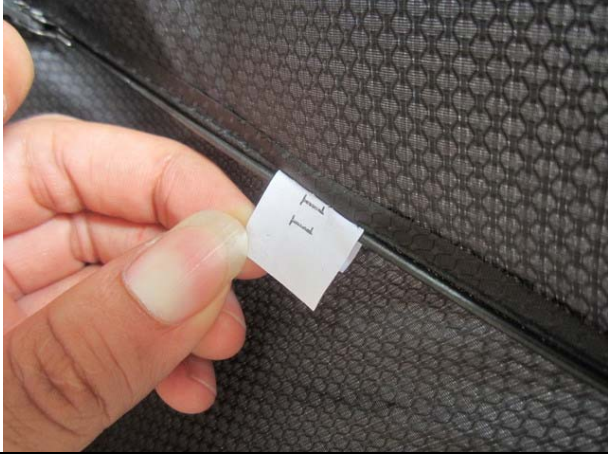
| 2 | All inspected samples were found worker number sewed on the product.<br> |

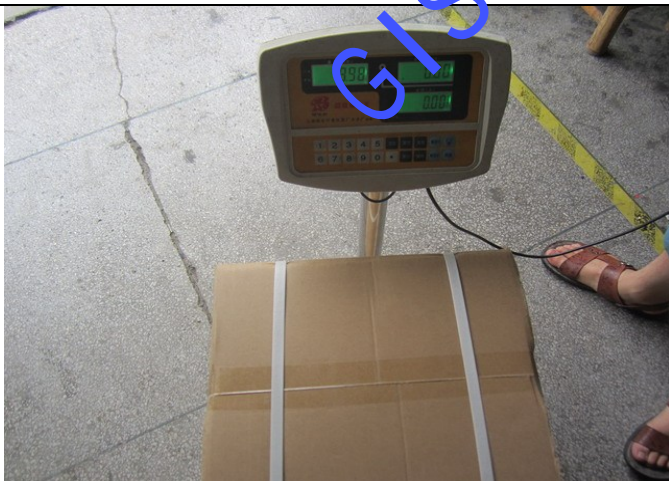
| Item No. | Carton size<br>(spec from client) | Carton size marked<br>on carton | Carton size<br>(actual) | Carton Weight<br>(spec from<br>client)(kg) | Carton<br>Weight<br>marked on<br>carton(kg) | Carton<br>(actual)(kg) |
|---|---|---|---|---|---|---|
| -- | -- | 34x31x42 | 34x31x43 | -- | 19.5 | 19.98 |

33 carton weight check

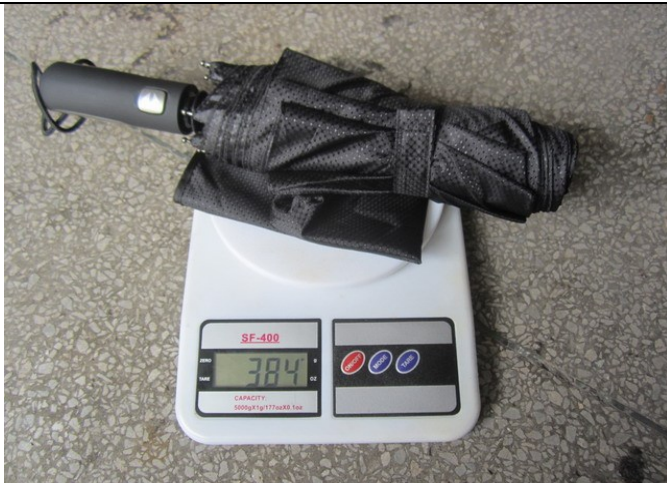
| - | Check points | Criteria | Sample size | Comment |
|---|---|---|---|---|
| | -- | 387g | | 384, 382, 385, 383, 385g |

38 product weight check

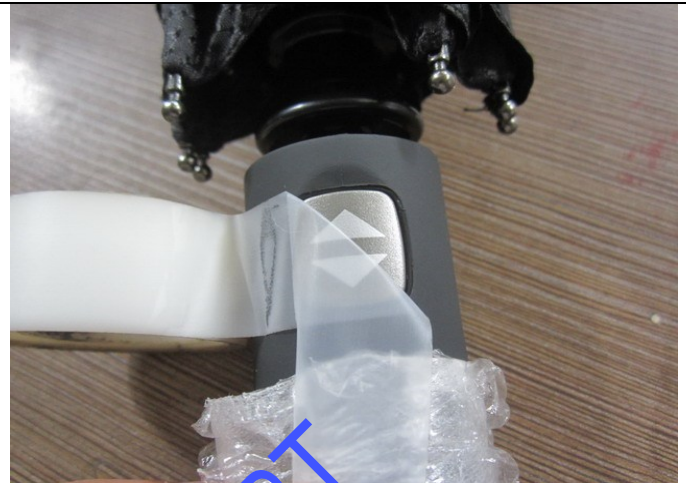
| - | Check points | Criteria | Sample size | Comment |
|---|---|---|---|---|
| 4 | Rub and tape test on Logo | With water for 15s,<br>3M,810 tape | (5Samples): | Conformed. |

39 tape test

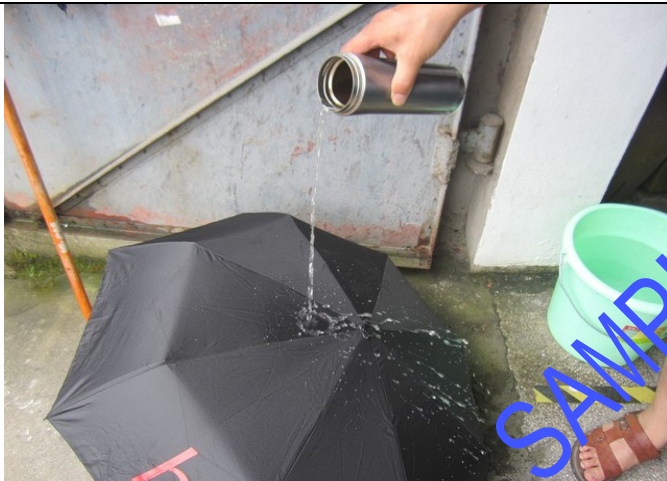
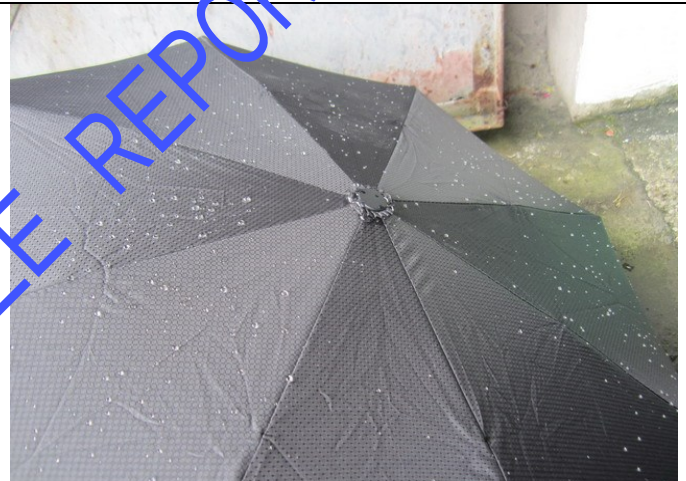
| - | Check points | Criteria | Sample size | Comment |
|---|---|---|---|---|
| 2 | Water proof check | | (5Samples): | Conformed. |

41 water proof check

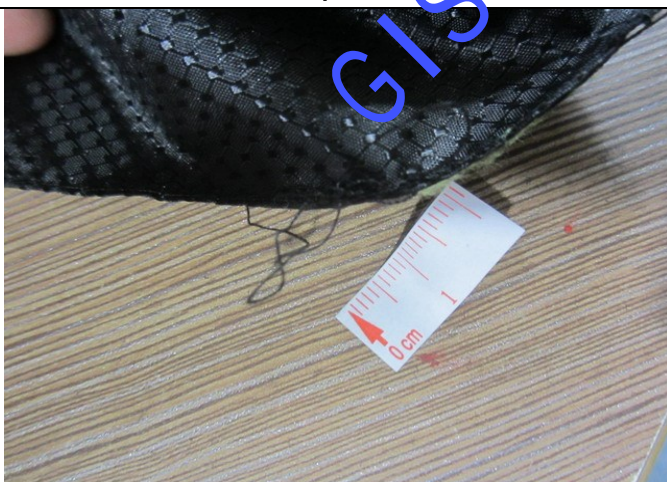
| 2 | Uncut thread end | | -- | -- | 7 |

43 defect-Uncut thread end-mi-1

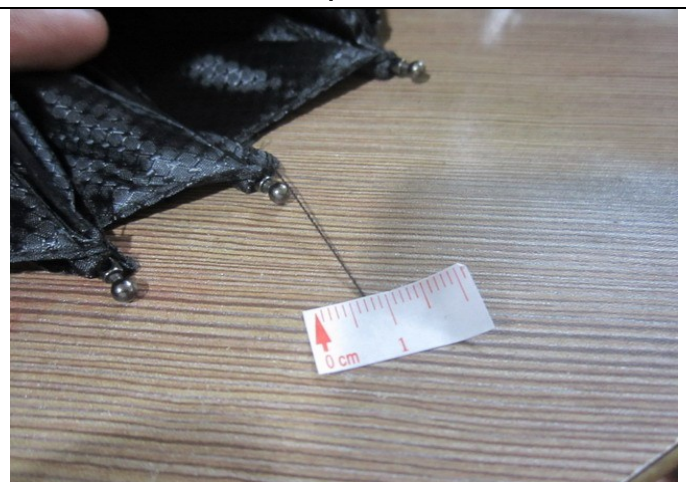
44 defect-Uncut thread end-mi-2

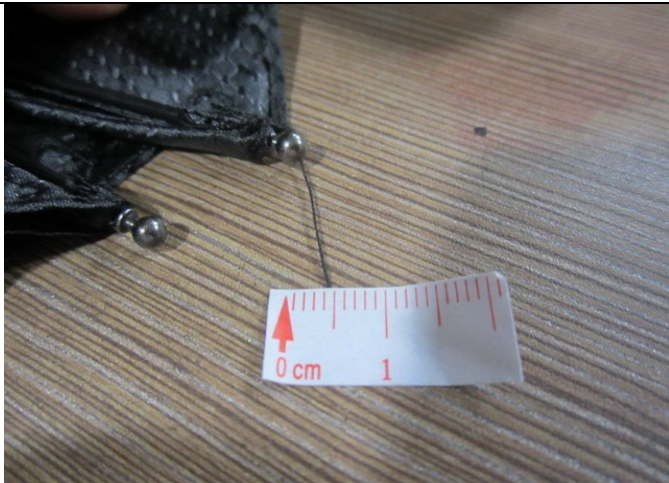
45 defect-Uncut thread end-mi-3

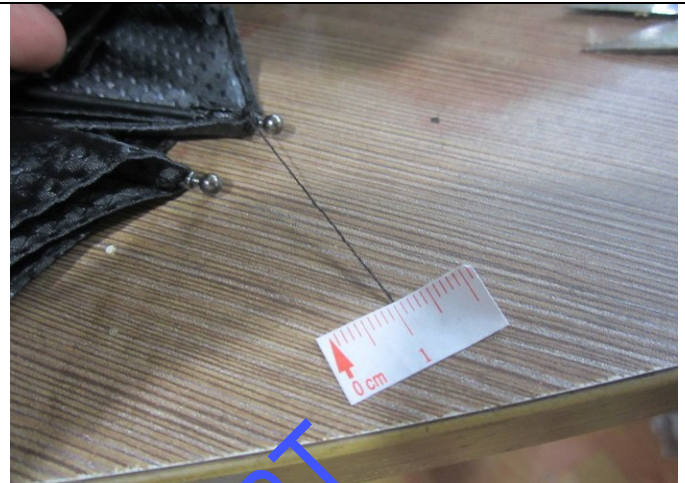
46 defect-Uncut thread end-mi-4

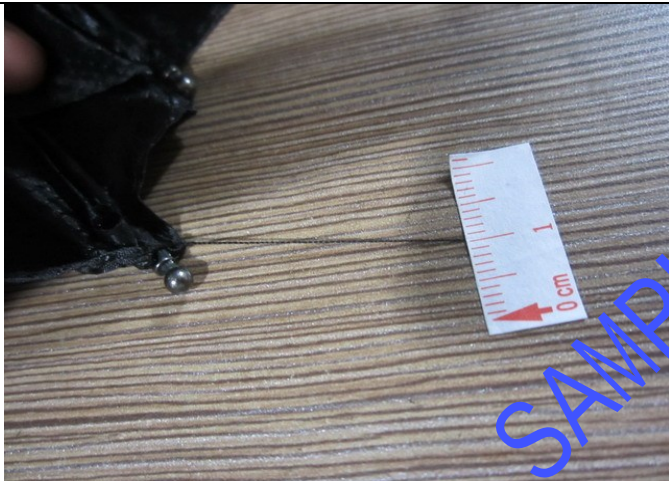
47 defect-Uncut thread end-mi-5

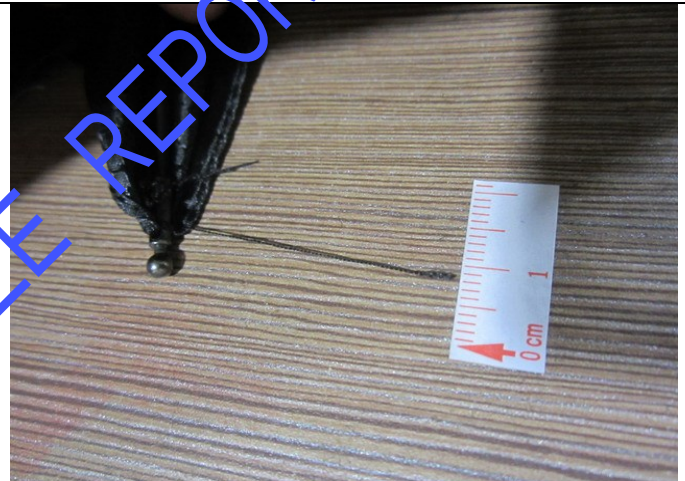
48 defect-Uncut thread end-mi-6

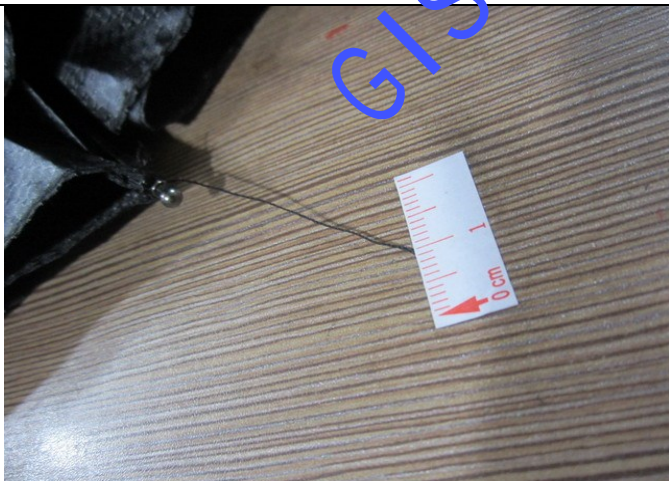
49 defect-Uncut thread end-mi-7

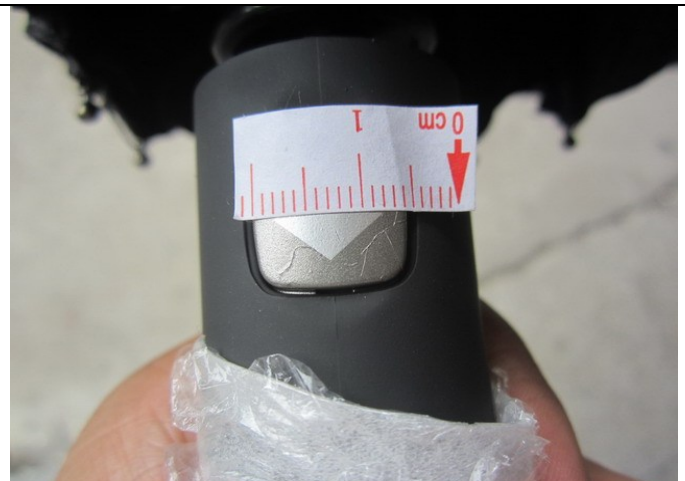
| 3 | Poor printing on control button | | -- | -- | 1 |

50 defect-poor printing on control button-mi

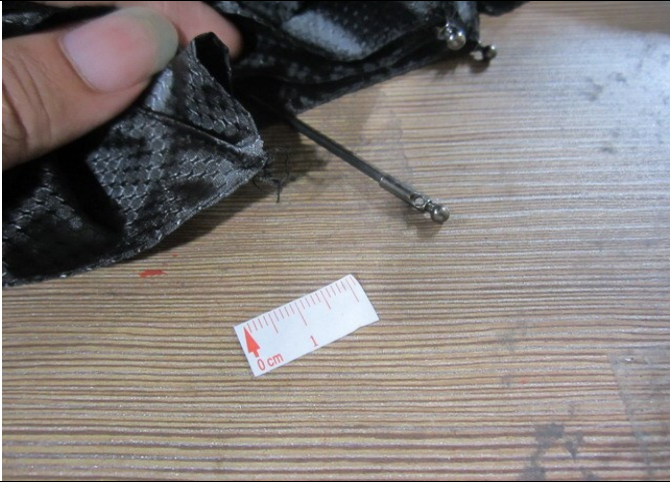
| 1 | Broken stitches on tip | | -- | 1 | -- |

| 51 defect-broken stitches on tip-ma | Nil |
