## SUPPLIER ASSESSMENT REPORT

Applicant	: --	Audited Company	: Xia *****
Attention	: --	Audited Address	: 24F, ***** Wuhan City, Hubei Province, China
Telephone	: --	Representative of Audited Company	: V*****
Fax	: --	Telephone	: 86-1*****
E-mail	: --	Fax	
Date of Audit	20XX-XX-XX

Report No: GIS-24031123

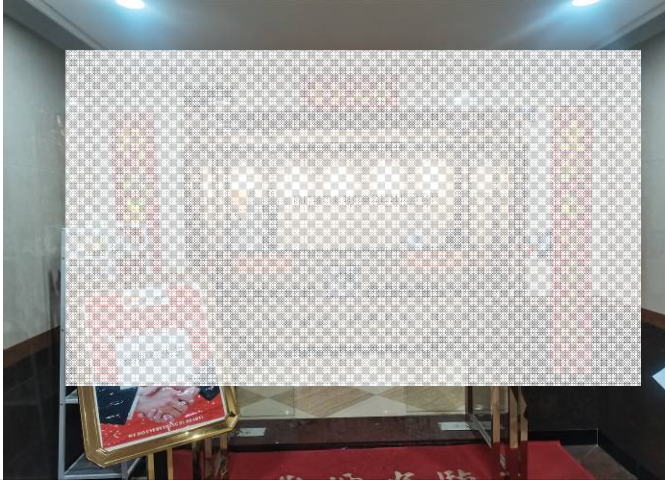
1. Entrance of supplier's office

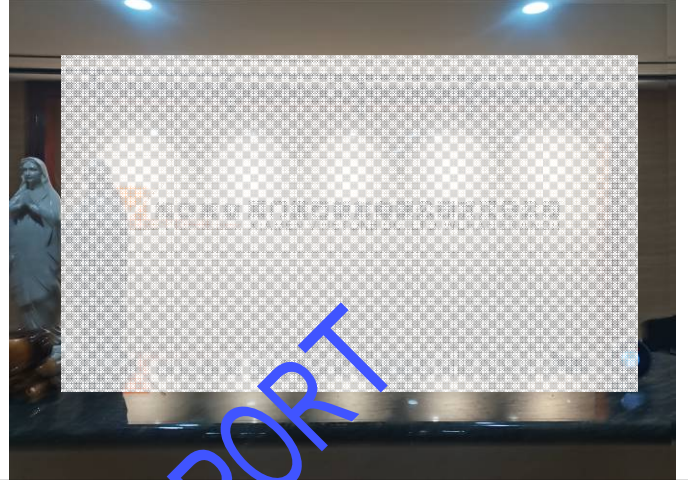
2. Supplier's reception

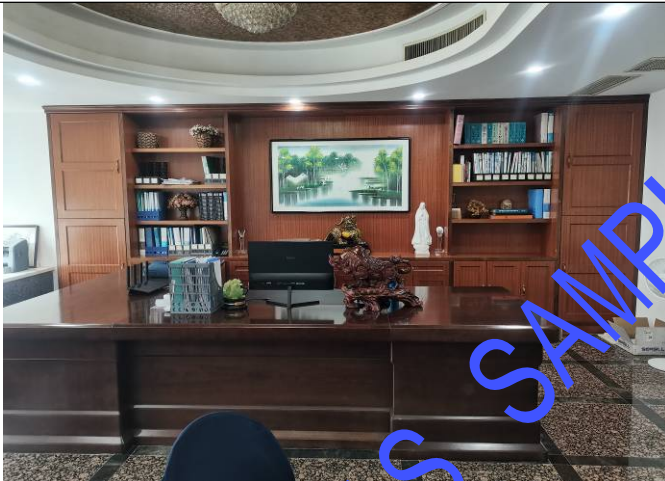
3. GM office

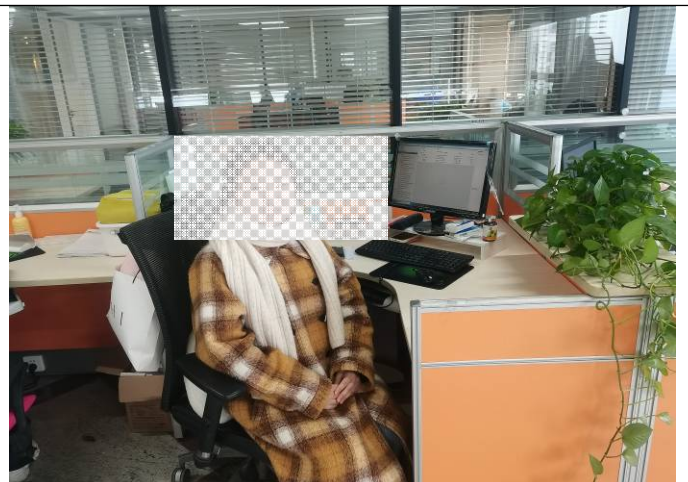
12. Supplier's contract-Vivian

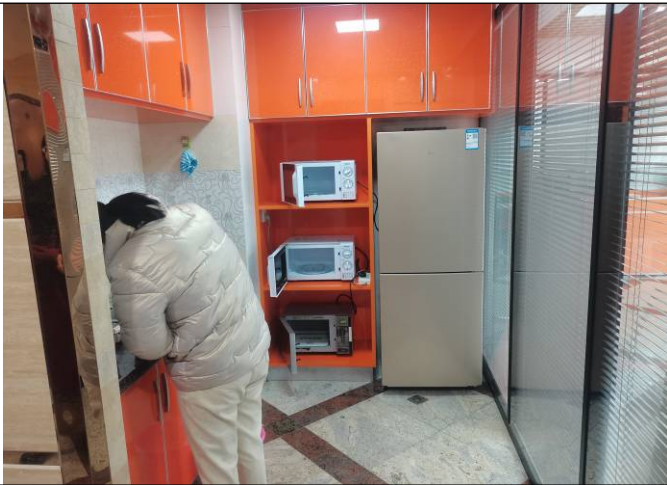
13. Resting area

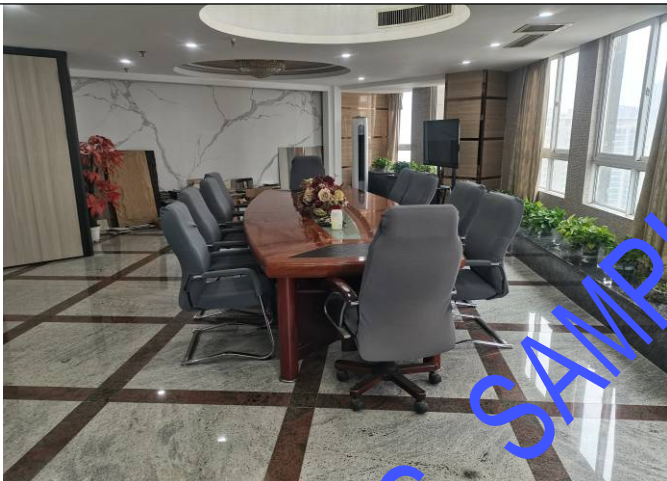
15. Meeting room

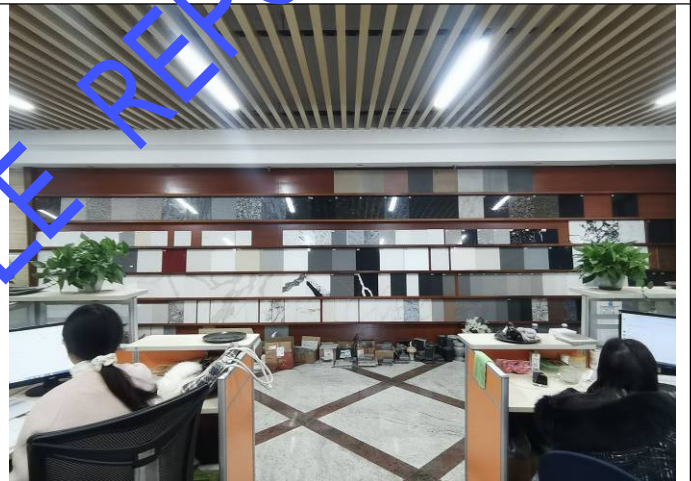
16. Samples shown area

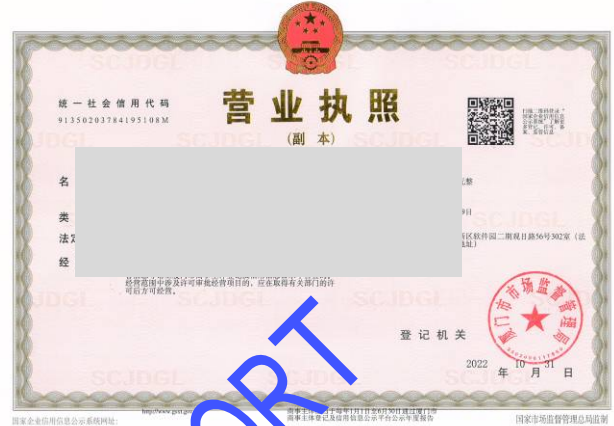
- 3) The supplier had an vailed export license.
- 4) Actual found the audited address -“2\*\*\*\*\*  
Wuhan City, Hubei Province, China”, was different from the registered address  
-“#1-\*\*\*\*\*  
Wuhan City, Hubei Province, China” shown on business license.

32.Business license for Xiamen head office

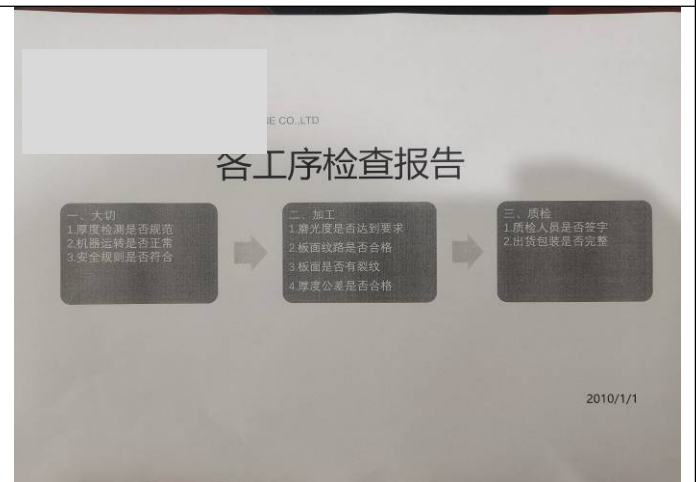
Item	Content	Comment
1	Is there a procedure to conduct random product inspection after final packaging in place?	Only "Inspection flow chart" was provided during visit, but no Working instruction and records of inspection was available.
2	Is there a procedure to conduct manufacturer production and ensure on time delivery? E.g. manufacturer production capacity study, min lead time...	No procedure to conduct the manufacturer production and ensure on time delivery, but the supplier claimed that usually, they would recheck the delivery date with the factory one week before shipment.
3	Is there a clear procedure for handling customer complaints?	Yes. Procedure of handling client's complaint was provided, but no client's complaint list and records was available. The supplier claimed that they would reply the complaint by email or instant messaging software such as wechat, etc.
4	Can the finished/packaged product be traced by lot identification to the appropriate raw materials test reports?	Yes. The supplier claimed that all they products could be traced according to order number.

48.Inspection process
