Report No : GIS-16120128

Report date : 20XX-XX-XX

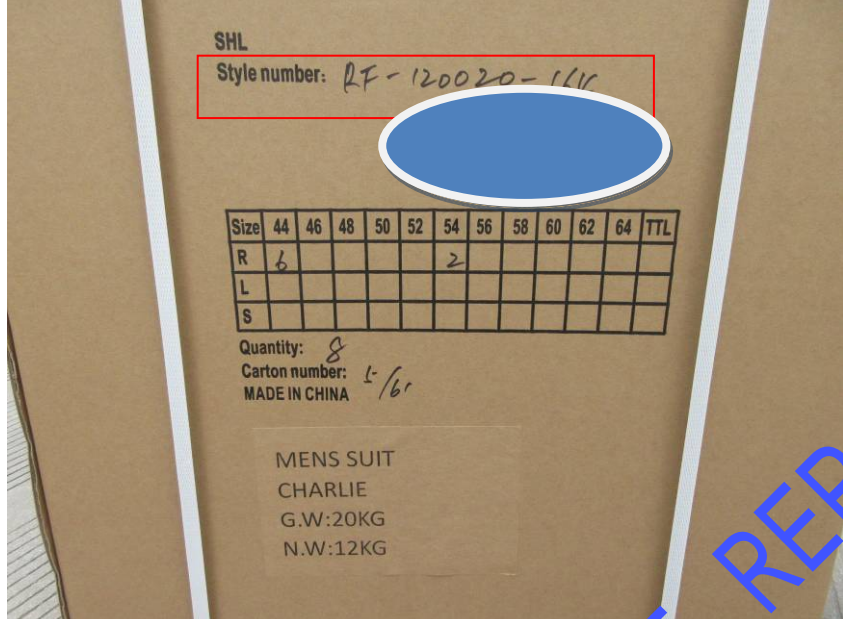
1	The actual loaded quantity was found 634sets (+10.1%) instead of 576sets stated on order sheet.
2	<p>Actual found "color" instead of "style number" on shipping mark.</p>
