Report No : GIS-13041592.

INSPECTION REPORT

Attn	:	-	
Supplier	:	-	
Factory	:	-	
Factory Address	:	-	
P/O No.	:	BTT-425/2012	
P/O Quantity	:	1572	
Model/Art/Style	:	MD-213B	
Product Description	:	Coffee Maker	
Inspection type	:	Pre-shipment Inspection	
Inspection method	:	<input checked="" type="checkbox"/> GWI-IE	
Inspection date	:	20XX-XX-XX

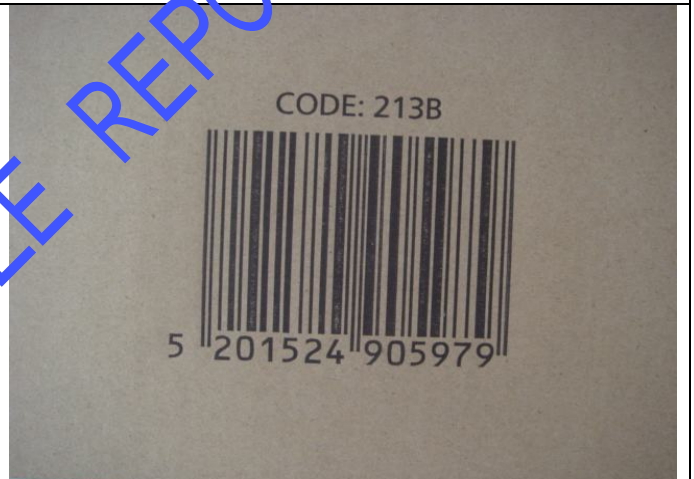
4_barcode

<table><tr> <th>Item No.</th><th>Barcode No.</th><th>Location</th><th>Barcode No.</th><th>Location</th></tr><tr> <td>MD-213B</td><td>5201524905979</td><td>A,B</td><td></td><td></td></tr></table>

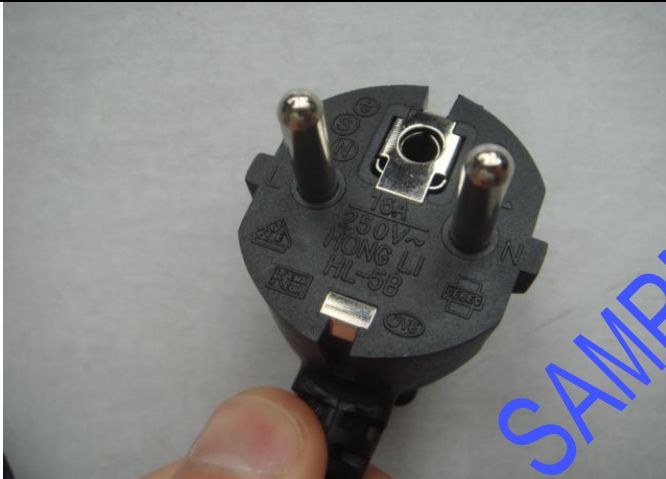
49_plug

Item for						
	Component	Trade Mark	Model	Technical data	Conformity mark	Does the Marking comply with certificate?
1	Plug	HANLI	HL-5B	16A 250V	VDE	Pass
2	Power cord	Hongli	H03VV-F	3*0.75MM2	VDE	Pass
3	Switch	--	--	XCK-017 10(4)A 250V	--	Pass
4	Thermal fuse	--	--	SF 214E Tf 216°C 10A 250V	VDE	Pass
5	Heater	--	MD-203	220-240V 800W	--	Pass
6	Thermostat	--	KSD301-cy	250V 12A 125°C	--	Pass
