Report No : GIS-15060333

INSPECTION REPORT

Table with 2 columns: Field Name and Value. Fields include Applicant, Attn, Supplier, Factory, Factory Address, P/O No., P/O Quantity, Model/Art/Style, Product Description, Inspection type, Inspection method, and Inspection date. Includes an image of a yellow excavator.

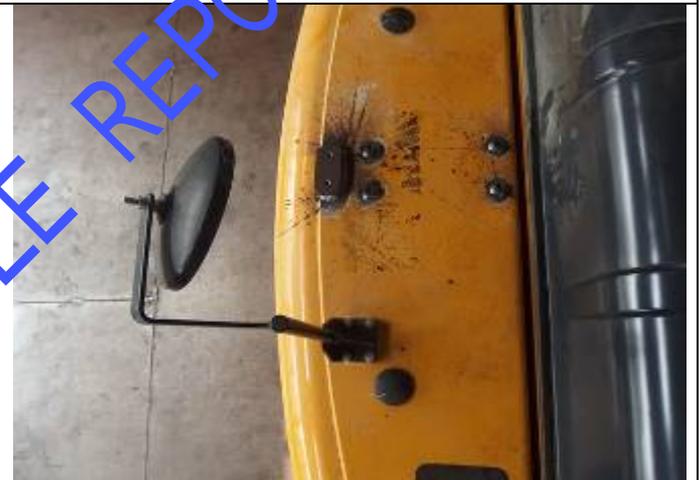
267 remark

1	Until the inspection finished, the fuel pump, logo, head light, rear camera and alarm light had not been installed yet.
2	The support of rear camera was not finished and dirty mark was found on product. Details refer to photos below.

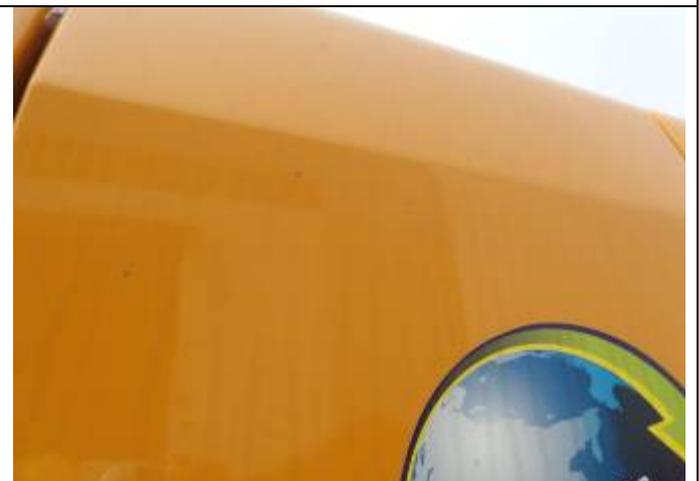
269 remark (2)

3	Actual found that the "JCM" logo on excavator was not removed. See photos as below.
