Report No : GIS-21040599

INSPECTION REPORT

Applicant	:	-	
Attn	:	-	
Supplier	:	-	
Factory	:	-	
Factory Address	:	Shanghai, China	
P/O No.	:	--	
P/O Quantity	:	2 sets	
Model/Art/Style	:	Hitachi EX120, Komatsu PC120	
Product Description	:	Used excavators	
Inspection type	:	Pre-shipment Inspection	
Inspection method	:	<input checked="" type="checkbox"/> GWI-IC	
Inspection date	:	20XX-XX-XX

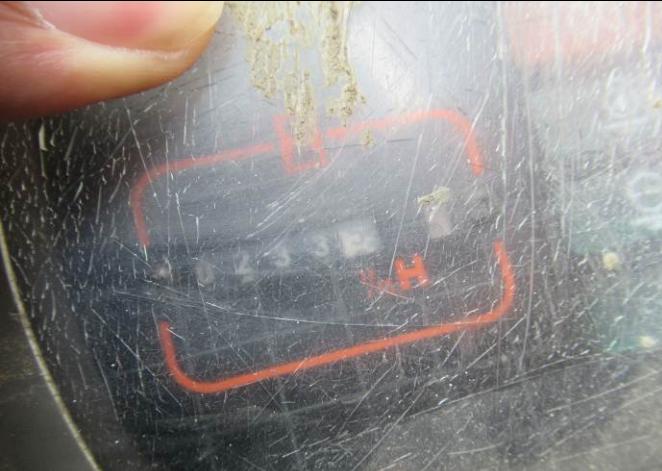
EX120: 2335Hours

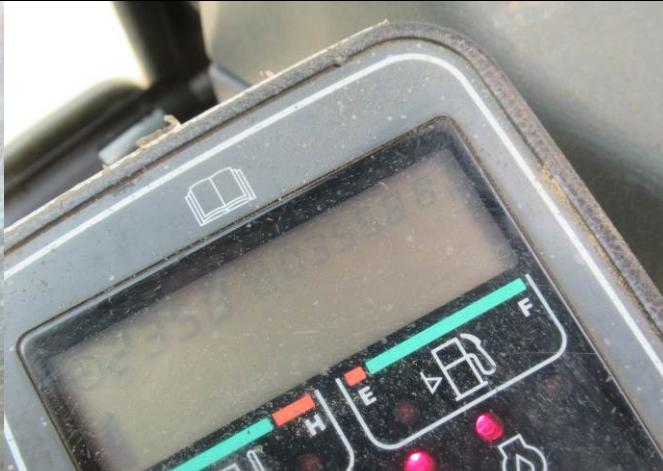
PC120: 3558Hours

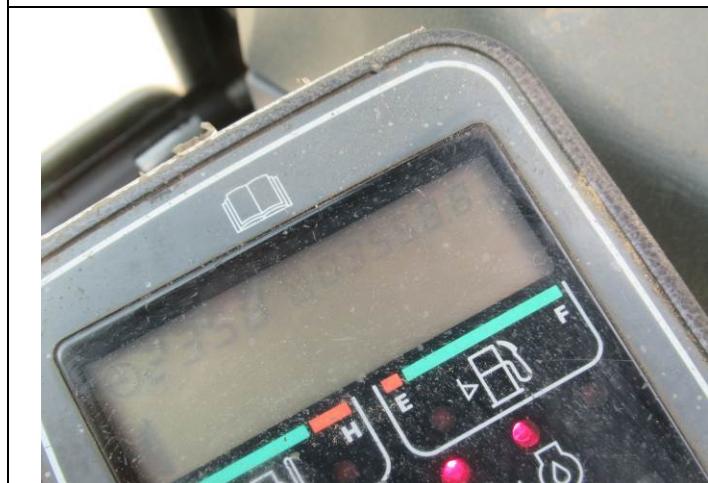
41 used hours

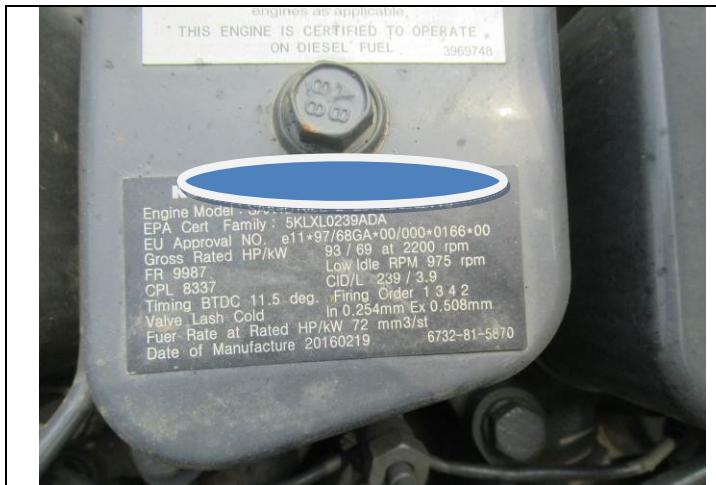
43 Engine rating label

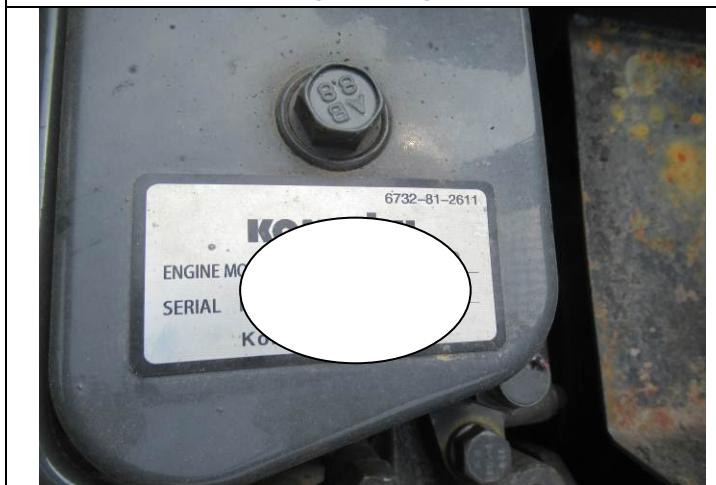
45 Engine rating label
