Report No.: GIS-2606036901

## Inspection report

| Product Description: | LED Robe Kugel gross 50cm, warmweiss<br>LED Robe Kugel klein 30cm, warmweiss<br>LED Tannenbaum gold 120cm IP55<br>LED Stern gold 60cm IP55<br>LED Laterne 120cm IP55<br>LED Rentier 130cm IP55<br>LED Schneemann gold 120cm IP55<br>Set of 3 lighted glitter candle IP55<br>LED Rentier mit Schlitten (Geschenkboxen) | | | | |

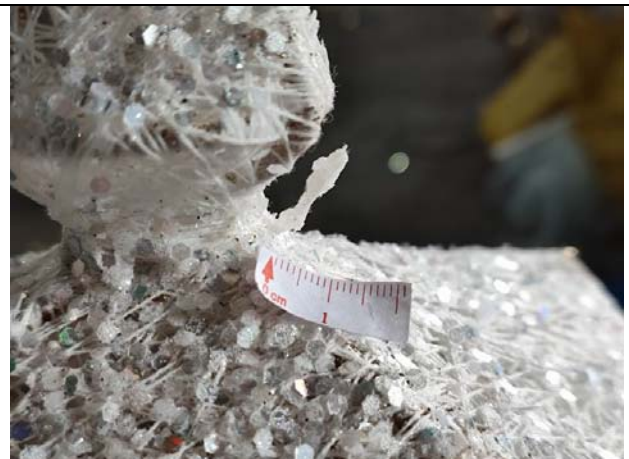
4. Minor defect- Glue mark on unit of item: 6.968.250
